# Manhole Inspection Summary

Manhole # S21CC\_062MH

Insp Date: **8/13/09 9:43 AM**

**Location** Address: **BEHIND 1900 RIGGS AVE**

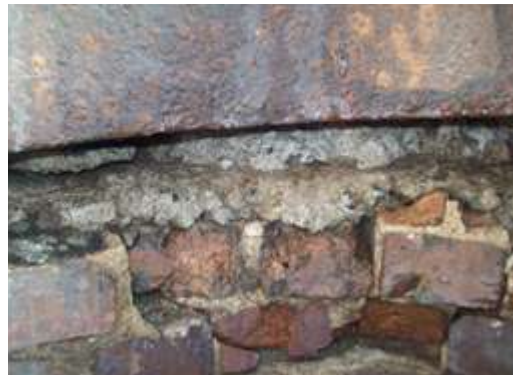
Defect 4

Condition: ☐ Sound ☐ Cracked ☐ Root Intrusion ☐ Loose Brick ☒ **Deteriorated**

DETERIORATED CHIMNEY

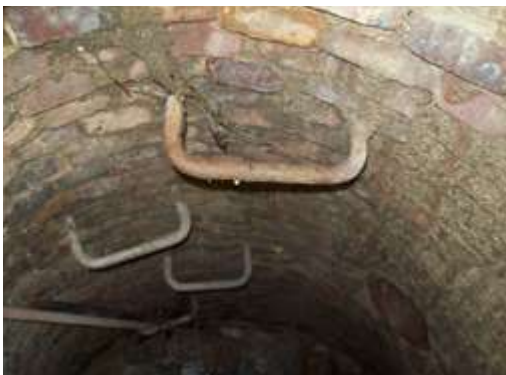
Defect 3

Count: **4** Missing: **0** ☒ **Corroded**

CORRODED STEPS

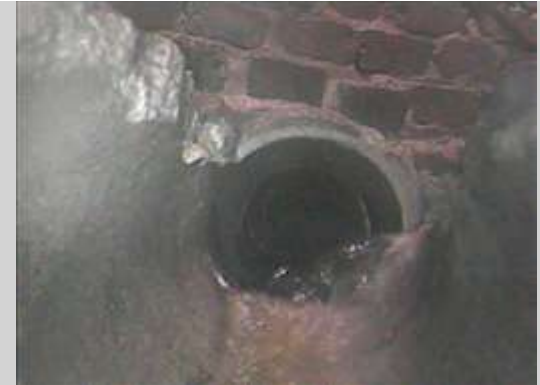
12 O'Clock Outflow

Pipe Height: **8.4** (in.) Rod and Bar (Angled)  
Pipe Material: **Clay** ☐ Pipe Lined  
Invert Depth: **8.70** (ft.) Flow Characteristics: **Slow**  
Deposits: ☒ None ☐ Mud ☐ Sludge ☐ Debris ☐ Grease  
Silt Depth: (in.) Deposits Extent:  
Infiltration: **None** Pipe Seal Cond: **Sound**

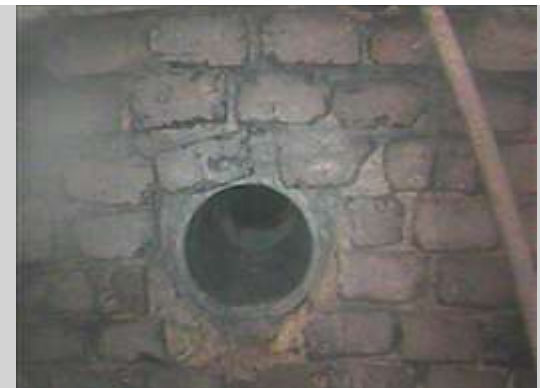
3 O'Clock Inflow

Pipe Height: **7.2** (in.) Rod and Bar (Angled)  
Pipe Material: **Clay** ☐ Pipe Lined  
Invert Depth: **4.71** (ft.) Flow Characteristics: **Slow**  
Deposits: ☒ None ☐ Mud ☐ Sludge ☐ Debris ☐ Grease  
Silt Depth: (in.) Deposits Extent:  
Infiltration: **None** Pipe Seal Cond: **Sound**

Drop: **Outside** Rod and Bar  
Angled: **Yes** Reading: **6.88** (ft.)  
Inv Depth: **7.88** (ft.)

Drop Condition: **Open**

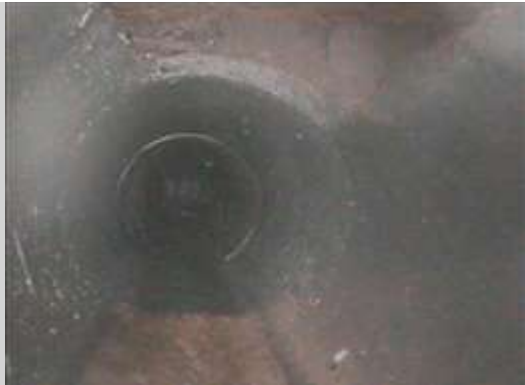
6 O'Clock Inflow

Pipe Height: **8.4** (in.) Rod and Bar (Angled)

Invert Depth: **8.60** (ft.) Flow Characteristics: **Slow**

Infiltration: **None**

Pipe Seal Cond: **Sound**

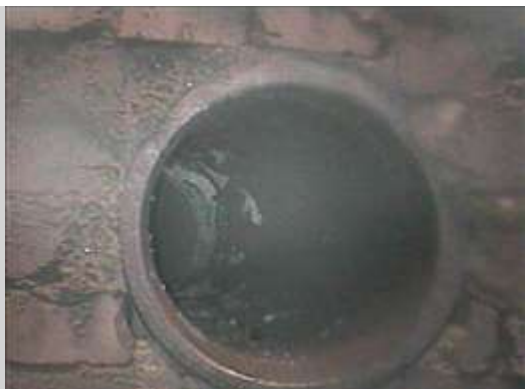
7 O'Clock Inflow

Pipe Height: **8.4** (in.) Rod and Bar (Angled)

Invert Depth: **4.98** (ft.) Flow Characteristics: **Slow**

Infiltration: **None**

Pipe Seal Cond: **Sound**
